Property Inspection Report

Sample Property Inspection Report

Property Address Sample Inspection Report
City Round Hill State Virginia Zip 20141

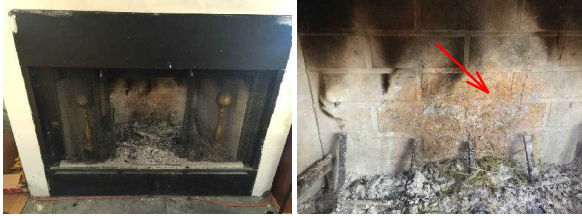
Defective Fireplace Construction: Prefab - **Loose or broken fire brick. Recommend evaluation and/or repair by qualified fireplace contractor before use.**

4. Living Room Fireplace Construction: Prefab - **Loose or broken fire brick. Recommend evaluation and/or repair by qualified fireplace contractor before use.**
